Landslides and related features interpreted from aerial photographs:
1:60,000 (black and white) 1959
1:80,000 (black and white) 1975

Photointerpretation and field check 1978,9
This report is preliminary and has not been reviewed for conformity with U. S. Geological Survey editorial standards.
Data on location of strip mines in part from:
Hayes, Philip T., 1977, Geologic map of the Sitka quadrangle, Johnson and Lawrence Counties, Kentucky;
U. S. Geological Survey Geologic Quadrangle Map GQ-1398, scale 1:24,000.

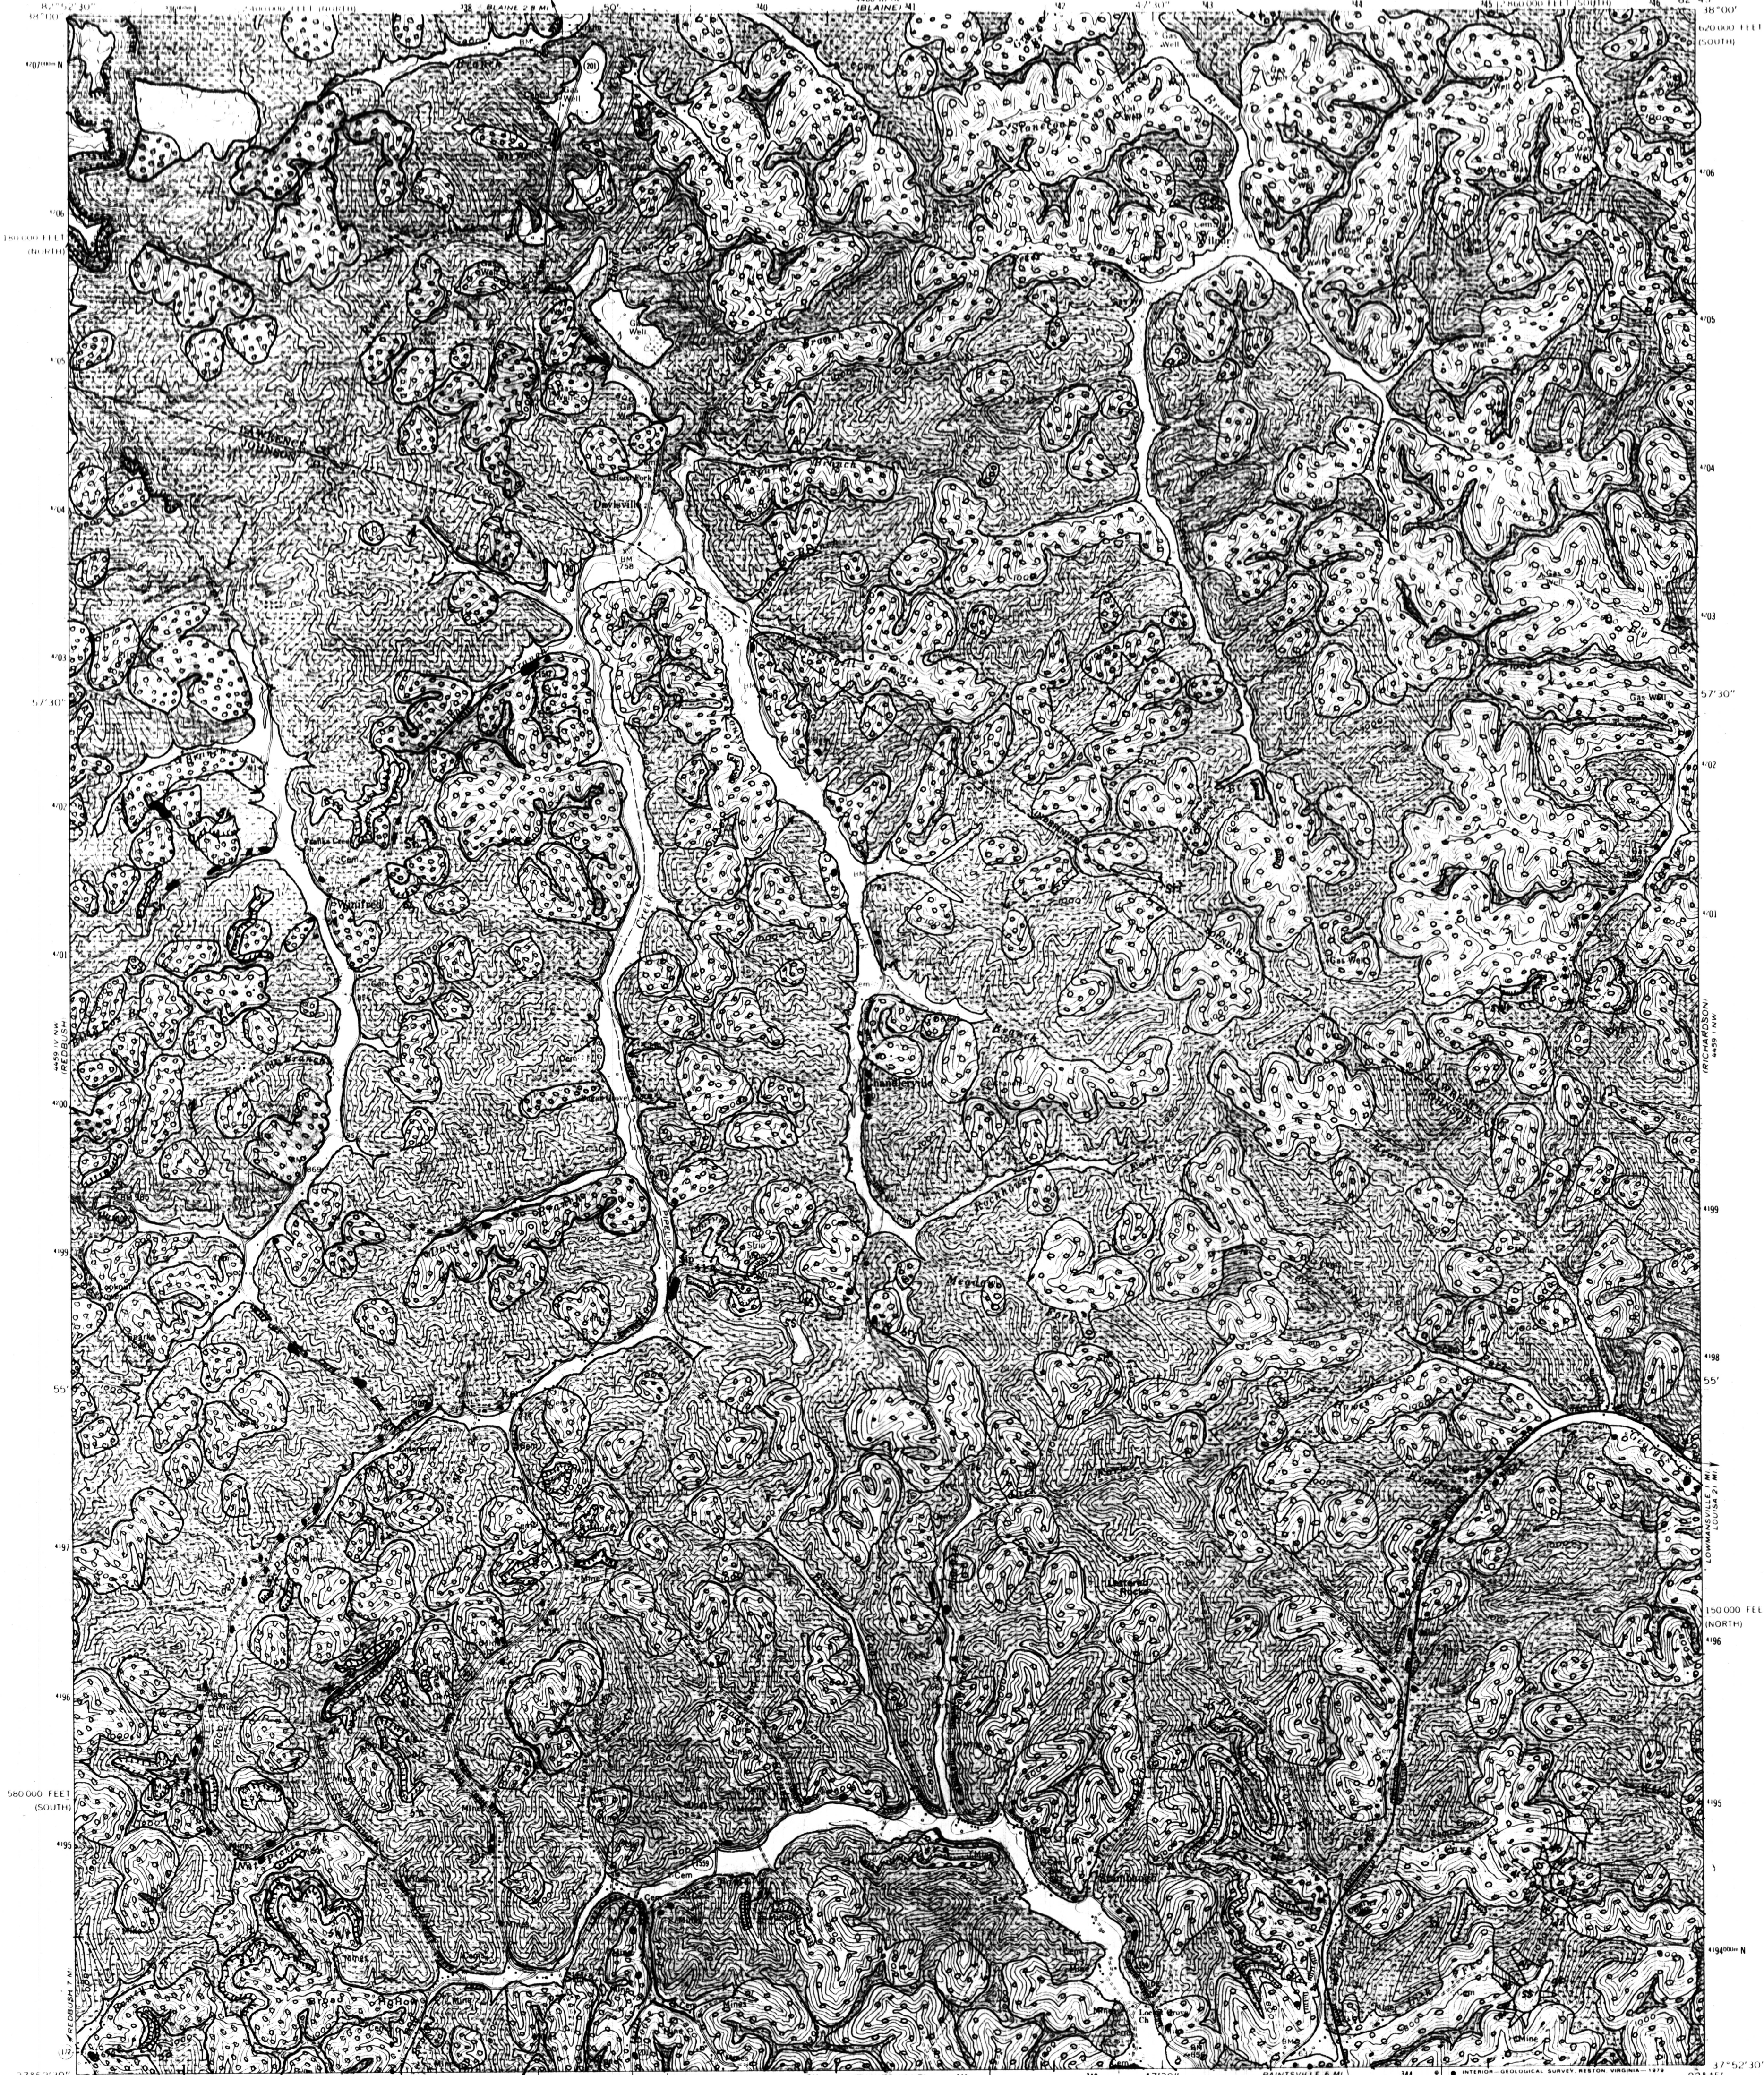
ACTIVE OR RECENTLY ACTIVE LANDSLIDE
Complex landslide composed of earthflow, debris slide, earth and rock slump. Identified from historical records, and from scars, debris and other field evidence. Ground extremely unstable; sliding accelerated by excavation, loading and changes in drainage conditions. May include areas with several active slides, too small to be shown separately. Questioned where doubtful.

OLD LANDSLIDE
Area of extensive hummocky ground caused by earthflow and earth and rock slump. Lacks clear evidence of active sliding. Relatively stable in natural, undisturbed state, generally not affected by small structures properly sited in areas away from the edge of the toe; can be reactivated by extensive, rapid excavation, loading, and changes in ground water and surface water conditions. Area of old landslide probably includes recent ones not identified from field evidence or otherwise documented. Upslope boundary of landslide generally defined by modified scarp, but downslope (toe) may be gradational and not well defined. Questioned where doubtful.

COMBINATION LANDSLIDE
Area of recent and old slides in which individual slides are not identified.

COLLUVIAL SLOPE
Valley wall along major streams with slope as steep as 40° (85%); stony, clayey silt soil up to 50 ft. (15 m) thick; commonly buttressed by a terrace or bench at the toe of the slope; very susceptible to sliding by cutting of toe area, removal of terrace or bench, and overloading; slide commonly activated without apparent cause.

COLLUVIAL SLOPES WITH LANDSLIDES
Landslides too small or obscure to map individually.

AREAS SUSCEPTIBLE TO DEBRIS FLOWS AND DEBRIS AVALANCHES
Primarily shallow, narrow ravines and chutes with accumulation of stony colluvium generally 10 ft. (3 m) or less in thickness; susceptible to rapid movement during intense rainfall. Most ravines and chutes designated show evidence of former debris flows and avalanches. Symbol & designates historical debris flow or debris avalanche.

AREAS SUSCEPTIBLE TO ROCKFALL
Steep, locally vertical, natural and man-made slopes and cliffs, 15 ft. (4.5 m) or more high; formed dominantly of sandstone, limestone, sandy shale, mudstone and claystone. Interbedded mudstone, claystone and shale weather rapidly leaving sandstone and limestone rock faces unsupported.

SOIL AND ROCK SUSCEPTIBLE TO LANDSLIDING
Soil and rock similar to that involved in landslides elsewhere in map area; primarily areas underlain by claystone, mudstone and shale associated with other rock types. Rock weathers rapidly on exposure forming clayey soil highly susceptible to sliding. Includes coves (U-shaped, shallow valleys) containing thick layers of clayey soil that are very susceptible to sliding where excavation breaks continuity of slope and where overloaded by artificial fill.

AREAS LEAST PRONE TO LANDSLIDES
Map areas in which no patterns or symbols are shown; primarily valley floors, ridge tops and broad benches; modification by excavation and fill may lead to local landslides.
